● Case Study 1

Castle Cement

Date: January 9th 2003
Location: Castle Cement, Ketton Site (UK)
Product: PAS 350 Audiosonic™ Acoustic Cleaner
Principal: Primasonics® International Ltd (UK)
Problem: solution required for the cleaning of the ID fan used with their cement kiln 7.

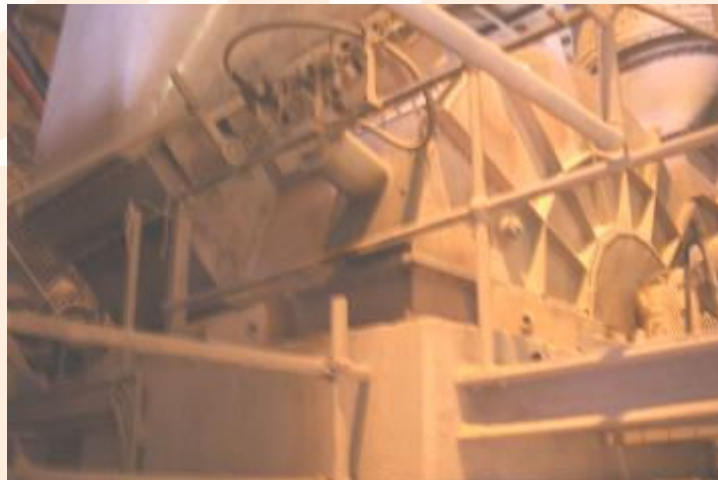
Engineering drawings of the fan and details of the material on the impeller were sent to PRIMASONICS® for their recommendation, based on which PRIMASONICS® selected the most appropriate model from their extensive range of Primasonics® Cleaners. A trial request form was then filled in by Castle Cement staff and returned to Primasonics®.

PRIMASONICS® supplied the AudioSonic™ Acoustic System directly to Castle Cement, Ketton plant, along with the accessories required i.e. mounting tube and flange, solenoid valve, flexible air line pipes. The mounting tube arrangement was welded onto the fan casing and the Primasonics® system was installed according to the instructions supplied.
