Cimenterie Nationale – Cement Plant

Fact file

Date: April 4th 2008
Location: Fond Mombin, Caberet, Haiti - Cimenterie Nationale
Product: Primasonics® Acoustic Cleaning System
Principal: Primasonics International Ltd (UK)
Problem: Build up on the side of his 6000 tonne cement silo

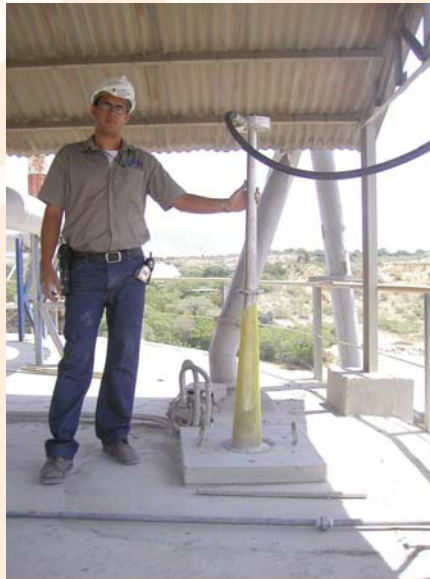
The equipment was despatched on an agreed trial basis and installed on an existing inspection hatch on top of the silo and the trial commenced using the recommended sounding pattern.
